National Highway Traffic Safety Administration

**DYNAMIC SCIENCE, INC.** In-Depth Accident Investigation

Contract DTNH22-94-D-27058 Case DSI-94-AB-023

#### TECHNICAL SUMMARY

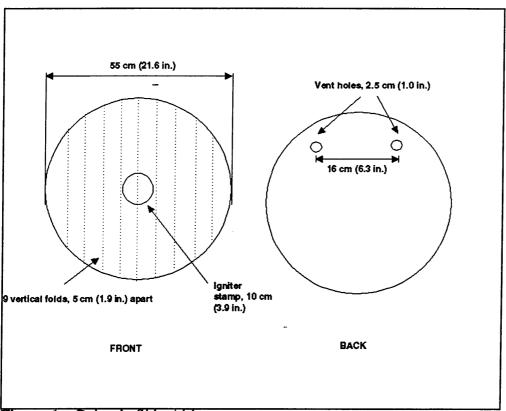
Figure 1. Driver's Side Airbag

The driver's side air bag module cover opened along the designed tear points.

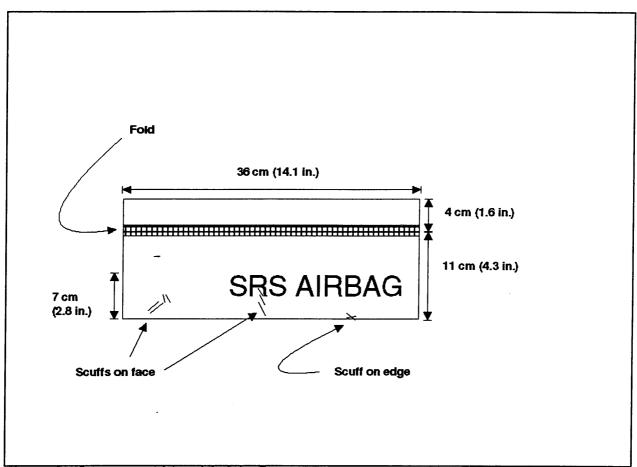
Figure 2. Passenger Airbag Module Cover

The passenger side air bag module cover opened along the designed tear points. The cover contacted the forwardmost portion of the child safety seat in this seat position. The flap surface was abraded from this contact and cover itself was deformed, primarily on the right side. The airbag itself sustained a vertical, linear scratch in its surface. The scratch was 14.0 cm (5.5 in.) in length, 6.0 cm (2.4 in.) to the left of the right-hand seam on the top and 9.0 cm (3.5 in.) to the left of the right-hand seam on the bottom.
